Restoration of the Delaware and Raritan Canal Outlet Locks and Towpath
Boyd Park, New Brunswick, New Jersey

Jan 1999

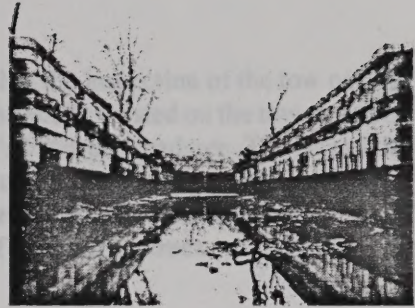
The southern section of the outboard lock walls constructed in 1834 were of "English Construction" and were composed of 8 rows of large granite blocks (1 ton each) laid on rubble masonry having timber sheathing on the face. The top 6 rows of the granite block walls had been displaced inward toward the lock (some areas nearly 1 foot) and a few of the blocks had been dislodged and had fallen into the lock. The timber sheathing was secured to the rubble wall, but was severely deteriorated at the top.

The proposed repair of the outlet lock granite block walls were to be executed with minimal disturbance to the original historic fabric still existing at the outlet locks. The plans proposed to reset the dislodged granite blocks (top 6 rows). Since the timber sheathing at this section was below water and out of view, a nailer was installed to the outside face of the existing sheathing below the granite blocks to secure the original deteriorated timber sheathing in place. The granite blocks and rubble stones which may have been part of the original outlet lock walls and which had fallen into the canal were to be retrieved from the locks and reused in the resetting and repair of the walls.

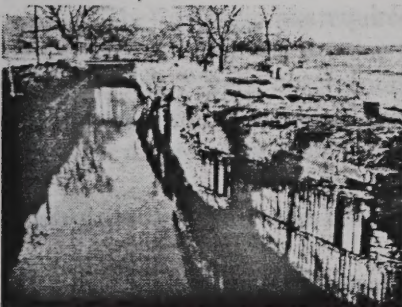
The inboard lock walls constructed in 1866 were also of "American Construction" composed of rubble masonry that was originally faced with timber sheathing. Approximately 90% of the upper and 70% of the lower halves of sheathing were missing and what remained was severely deteriorated. There were also areas of missing mortar in the walls, and the top nailers for the sheathing were severely deteriorated.

The plans proposed to replace all missing and loose stones. The stones were reset using the existing stones that were retrieved from the locks. A mortar mix consisting of 3 parts lime to 6 parts sand and 2 parts cement by volume was specified. This mix had been approved by the HPO for use on other historic restoration projects. Water was added to form the proper consistency but was not to exceed 5½ gallons per bag of cement.

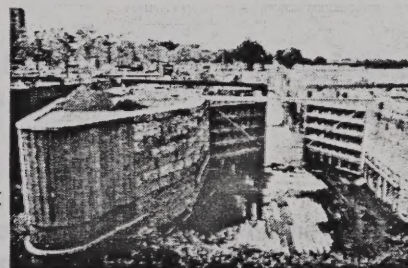
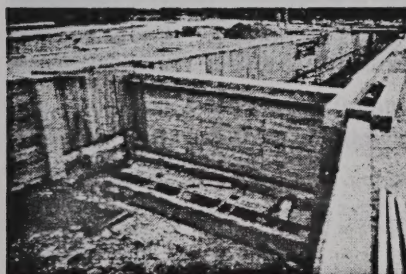
The drop gate consisted of heavy timber framing with timber sheathing on both faces. The area between the timber sheathing was filled with gravel to act as counter weights to counter natural buoyancy. In its closed position, the gate was angled to the vertical to allow it to fall under its own weight when opening.

The operating mechanism of the drop gate consisted of 2 rows of 5 paddle gates. After further investigation during construction, the paddles were found to be "frozen" in the closed position. Since it was proposed to lock the drop gate in the "closed" position, it was imperative that the inboard lock had sufficient water flow. One row of paddles were removed and placed on the inboard lock floor for future investigation. The new drop gate was secured in the closed position and all debris within the existing timber sill was removed.

All dimensions and configurations for the new gates were taken from accurate field measurements of the existing deteriorated mitre gates and drop gate. Missing portions of the existing gates were determined from old photographs, historical documentation, and old specifications from the Bald Eagle and Spring Creek Lock. Additional details of the iron pivot bottom, collar, wickets, wicket rods and bumpers were adapted from plans of the Kingston Lock on the D & R Canal. The details were judged by both historians and engineers to be a close replica of the historic details as evidenced by old photographs.

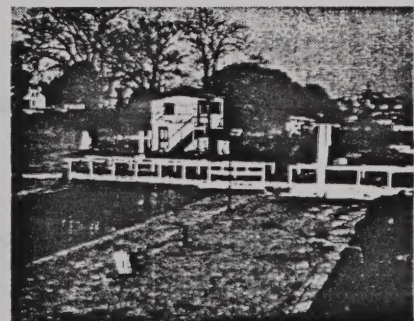
Based on the old photographs, the original swing bridge was thought to be a wooden king post structure with wooden pedestrian bridge rail, wooden ramps on either ends leading off the bridge and steel cables suspended from the king post. The pedestrian bridge rail had openings on both sides for access to the island.

The historic geometry and details of the proposed pedestrian swing bridge were based primarily on the old photographs of the outlet locks and supplemented with details taken from plans of the vehicular swing bridge at the D&R Canal Kingston Locks. Details from the as-built plans of the Rideau Canal that was built in 1866 (the same year that the inboard lock of the D&R canal outlet locks was added), were used to replicate the details for the pivot and wheel system that the bridge turned about. Because the wheels were hidden from view, the contractor proposed using galvanized cast high tensile ductile iron rigid wheels with Timken bearings.

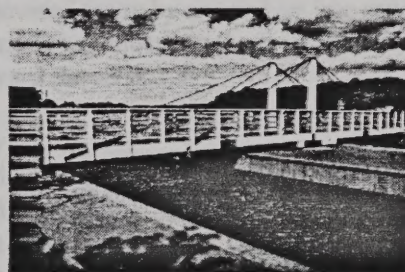
Another issue that had to be addressed during the design phase was the height of the pedestrian bridge railing. The original pedestrian bridge rails appeared to be wooden posts with a wooden top rail and cap. The current AASHTO Code required that the pedestrian bridge rail be 3'-6" minimum in height and openings between the rails should be such that a 6" sphere cannot pass through. By the present code standards, the "historic" rail from the old photographs would not meet code specifications for use on a public facility. The proposed pedestrian bridge rail was designed to have the same features as its historic counterpart but was supplemented with wooden intermediate rail elements in order to meet code requirements. In addition, the king post, fascia side of beams, railing posts and top rails were painted white to illustrate what existed historically. As previously stated, the steel hardware was painted brown.

For safety reasons, two maintenance access gates to the island were installed, instead of the original openings in the pedestrian bridge rail to prevent public access to the island. They were located on either side of the bridge at the same location where the openings were from the photos.

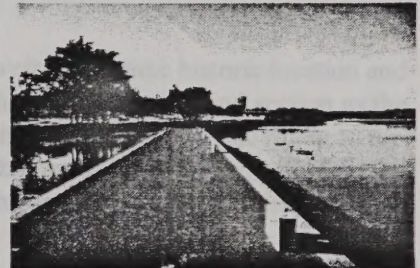
The existing timber cribwall was in a badly deteriorated state with many sections completely decayed and others only partially standing within the tidal zone. The deadmen ends were generally deteriorated providing little or no lateral support to the parallel timbers. Piece meal reconstruction would have been unattractive and questionable as to how long it would last before future repairs would become necessary. It was therefore proposed to entirely remove the rotting cribwall and reconstruct it with the historically correct dimensions and materials. The top width between top timbers was set at 14 ft. as per the existing and the timbers on the canal side stepped 3" between rows. All trees were removed within the historic section limits and no trees were planted within these limits since historically none had existed.

For economic reasons, it was proposed to use 1" steel tie-rods which were galvanized and coated with coal tar coating, instead of the "historic" unshaped logs for the deadmen since the deadmen would be backfilled and thus hidden from public view. A timber plug was used at the ends of the tie rods to give the illusion that they were the timber deadmen ends and thus the same view as existing.

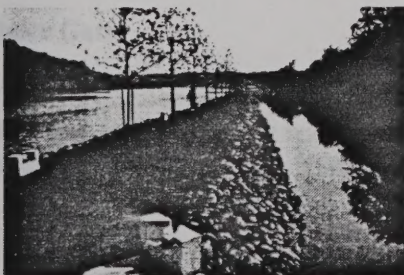
A non-historic towpath section for the remainder of the towpath was developed entirely out of economic necessity. The vast quantity of sawn, treated and placed timber required made it cost prohibitive to reconstruct the entire towpath to its historical beginning given the available project budget.

The non-historic section used maintains the historic 14 ft. towpath width but utilizes riprap slopes. Although it is unlikely that the existing crib wall can be salvaged as part of a future rehabilitation project, it was left in place as requested by the State Historic Preservation Office and simply covered by the riprap stone, although localized conflicts with riprap layer were removed. In this manner the timber was preserved to the best reasonable means for future archaeological investigations or considerations. An Impervious liner (Claymax

600SP Geosynthetic Clay liner) was used below 12" thick riprap on the canal side. An 18" thick layer of riprap was used on the river side (designed for the flow of the Raritan River). A 3" thick layer of crushed red shale (prevalent in the New Brunswick area) mixed with stabilizer (a patented non-toxic organic binder) was used for the top surface of the towpath section.
